Influence of welded Joint Structure on Fatigue Strength of the Impact Loaded Weld Fillet Joint between Radial Carrier and Rapping Device Drive Shaft

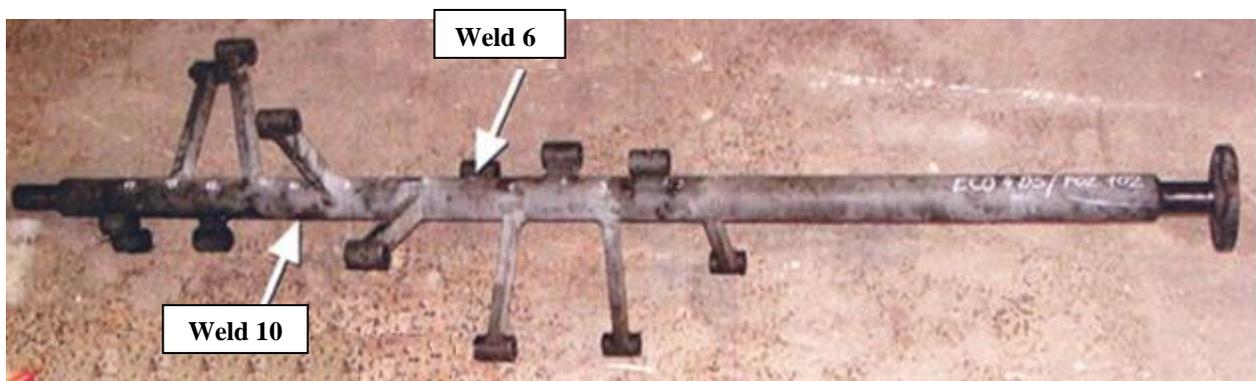
Laboratory researches were conducted on rapping device's drive shaft with welded radial carriers, Figure 2. Welded joint fracture occurred at shorter radial carriers. In paper [1a] calculations were conducted for shorter radial carriers, which are here going to be tested visually, ultrasonically, by measuring hardness and by metallographic testing. For determining validity of chosen additive material in welding, chemical analysis of welded joint and base material of the shaft will be conducted. Drive shaft contains 14 radial carriers. After visual and ultrasonic testing two samples of the welded joints were selected, on which hardness and metallographic testing will be conducted, Figure 2. "Weld 6" was selected because of detected ultrasonic microcrack, "Weld 10" was selected because of occurrence of the fracture and total separation of radial carrier from the drive shaft (Figure 3). In "Weld 10" adhesive connecting was detected, which reduces carrier capacity of the welded joint.

Fig. 2 Rapping device's drive shaft with welded radial carriers.

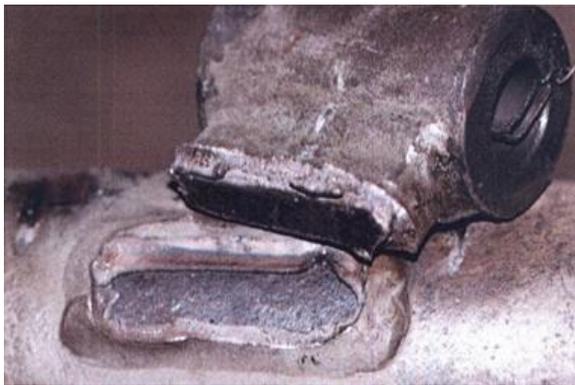
Fig. 3 Complete separation of the radial carrier from the drive shaft (“Weld 10”)

that hardness is very high in the area of heat influences of the welded joint between drive shaft and radial carrier, even more then 300 HV10. That state of material in practical appliance is unacceptable. That caused the damage, i.e. adhesive disconnection, on the sample “Weld 10”. Measuring hardness was conducted according to the norm HRN EN 9015-1.

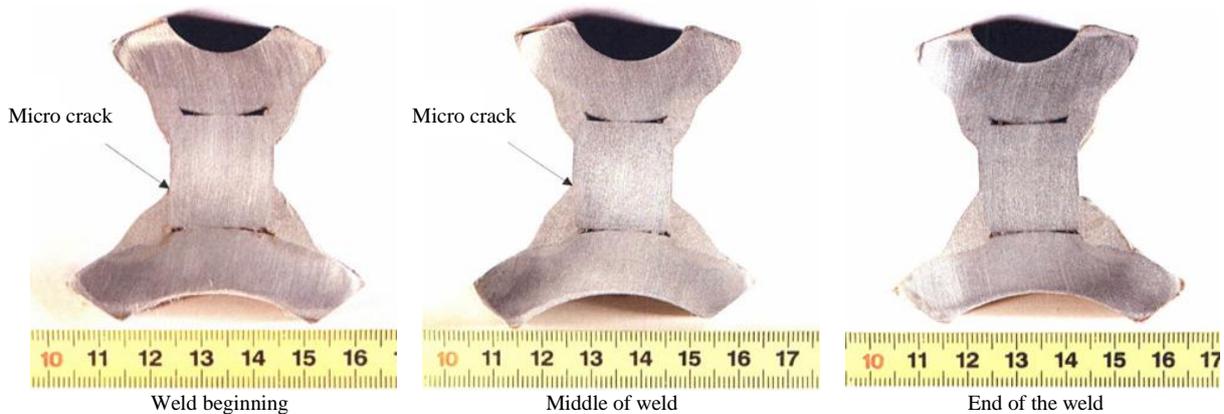
Fig. 4 Cross-sectional surfaces of the sample “Weld 6”

“Weld 10” was cut only in the middle of the weld joint (Figure 5). Visual testing of the samples proved that welded joint was made in one passing of the tool. At welded joints were visible cavities of unacceptable dimensions, as well as adhesive connections, especially with welded joint of the radial carrier and the shaft.

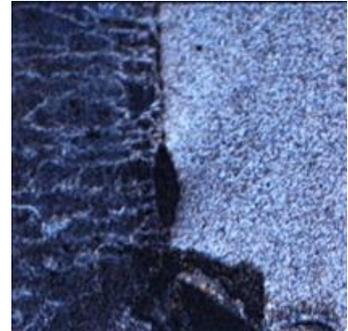
Picture 345

Location: Heat affected zone of welds - vertical carrier (HAZ)
Description: Defects in the form of cracks and cavities revealed in the joint of the weld and vertical carrier

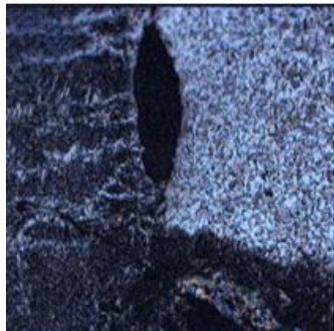
Picture 345a

Location: Heat affected zone of welds - vertical carrier (HAZ)
Description: Detail

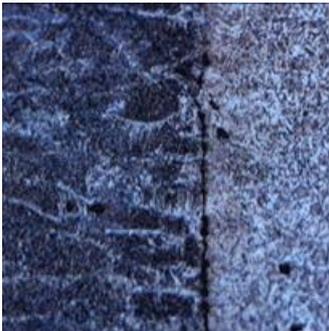
Picture 345b

Location: Heat affected zone of welds - vertical carrier (HAZ)
Description: Longitudinal crack which is moving from the perceived voids.

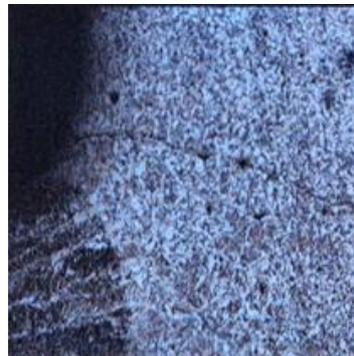
Picture 357

Location: Heat affected zone (HAZ)
Description: In the material formed transversal cracks can be observed
